WL-TR-91-4032
DOT/FAA/CT-91/23
VOL II, Part 2

COMPOSITE FAILURE ANALYSIS HANDBOOK
VOL II - TECHNICAL HANDBOOK
PART 2 - ATLAS OF FRACTOGRAPHS

R.J. Kar
Northrop Corporation
One Northrop Avenue
Hawthorne, California 90250-3277

February 1992

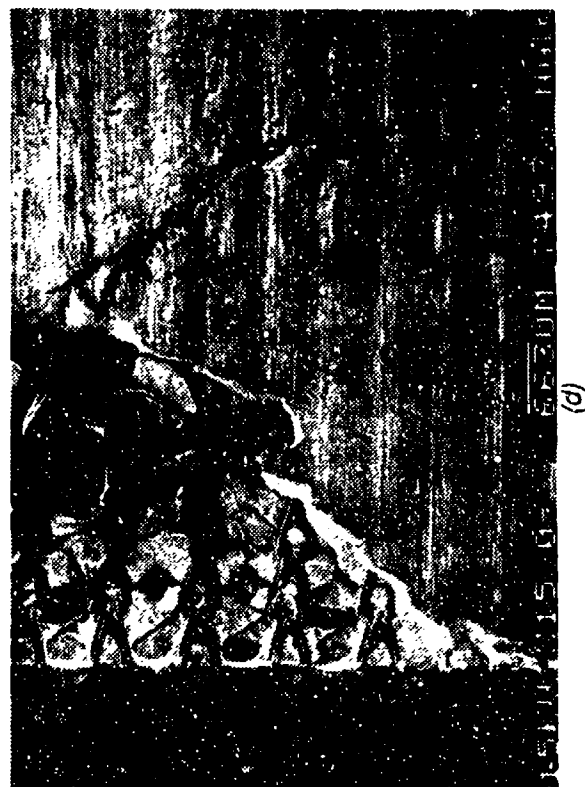
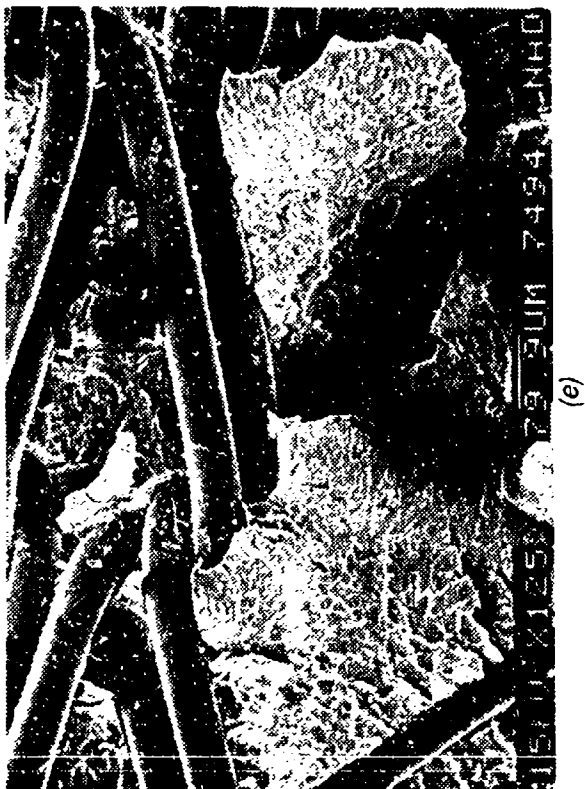
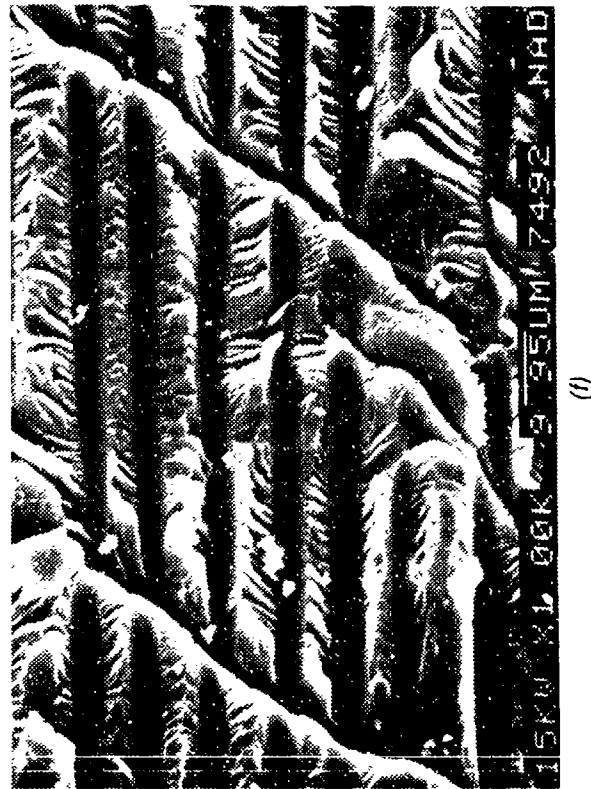
Figure 10-6. (Continued)
 (d), (e) Cohesive Failure in FM 300 Adhesive
 (f) Peel Characteristics in Fractured Adherends
 CD = Crack-propagation direction

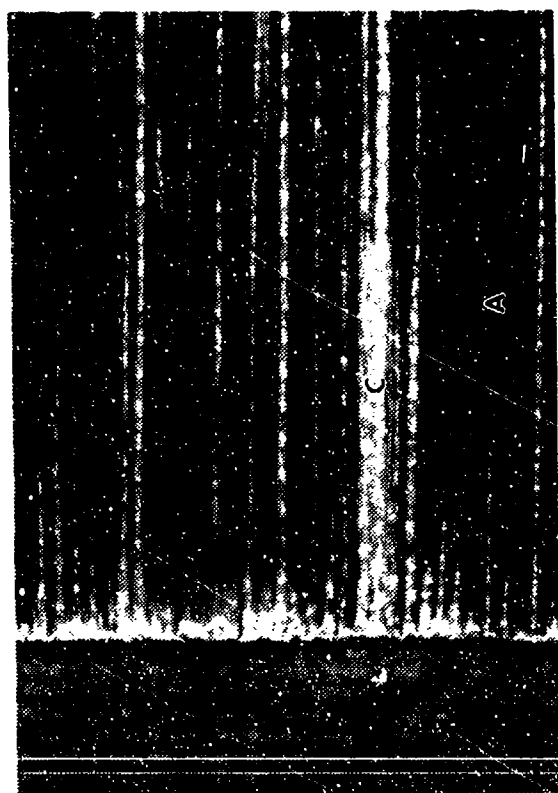
Figure 10-7. Optical and SEM Photographs of Fracture in Unidirectional AS4/3501-6 Gr/Ep Adherends Bonded With FM 300 Adhesive, Larger Lap/Strap Ratio and Tested Under Mode I Tension and Mode II Interlaminar Shear

(a) Macro photograph of Fracture

(b), (c) Low Magnification (4X) Photographs Showing Cohesive (C) and Adhesive (A) Failure Characteristics

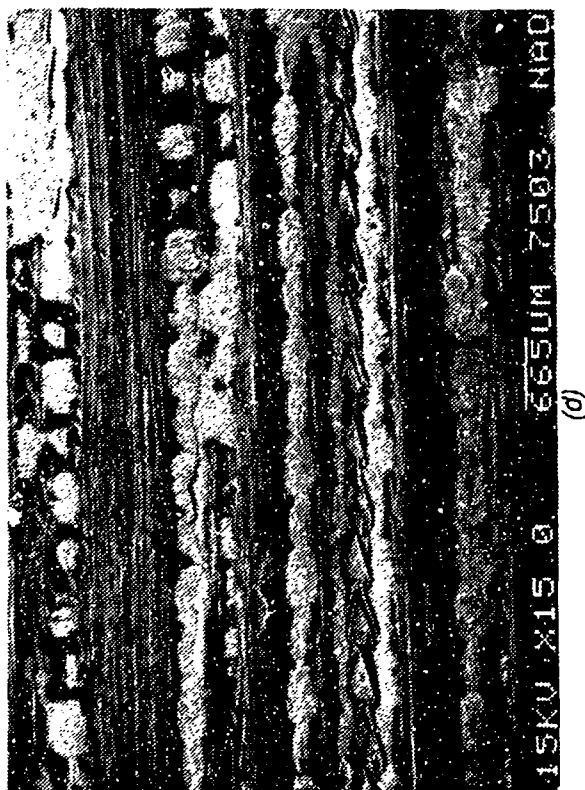
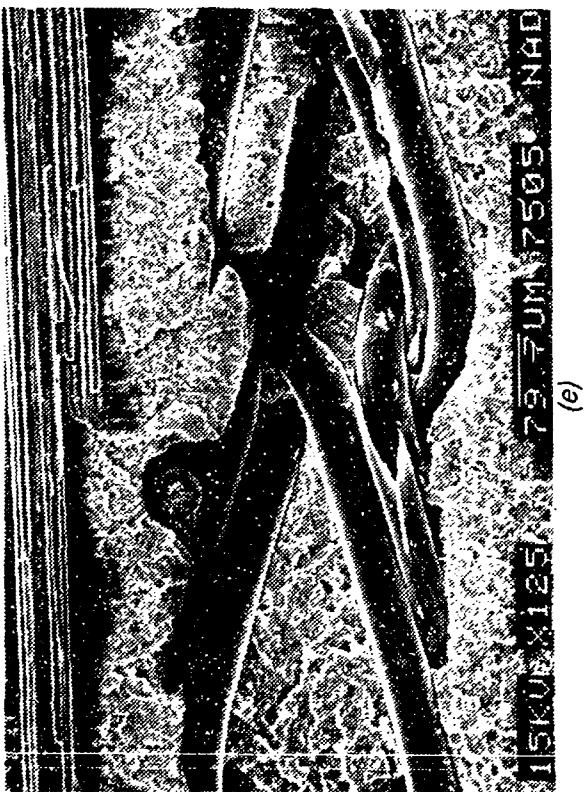
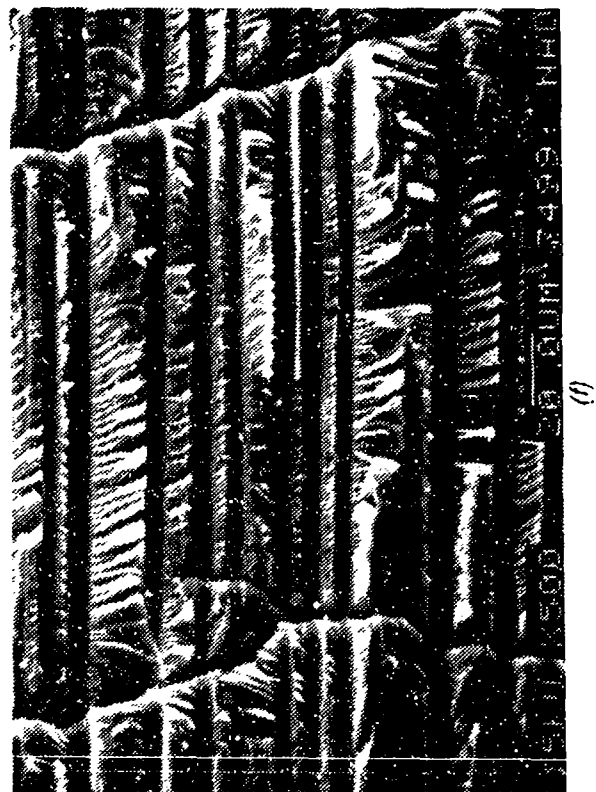
Figure 10-7. (Continued)
 (d), (e) Cohesive Failure in FM 300 Adhesive
 (f) Peel Characteristics in Fractured Adherend
 CD = Crack-propagation direction

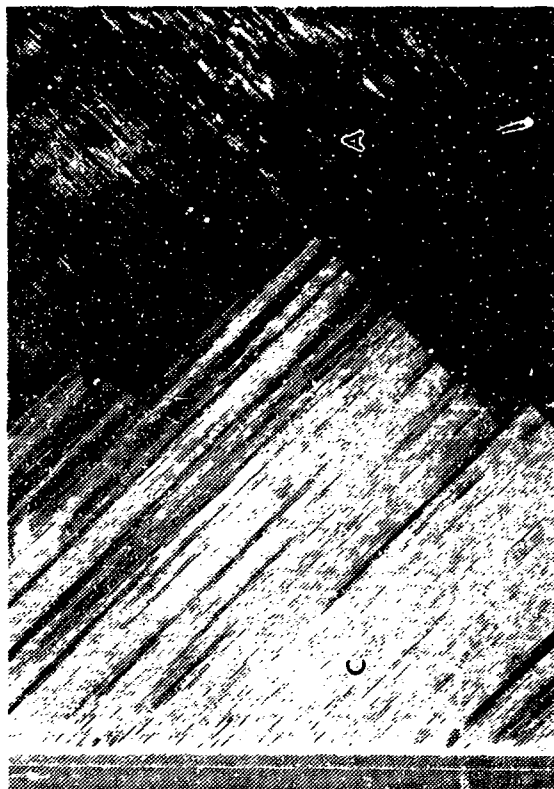
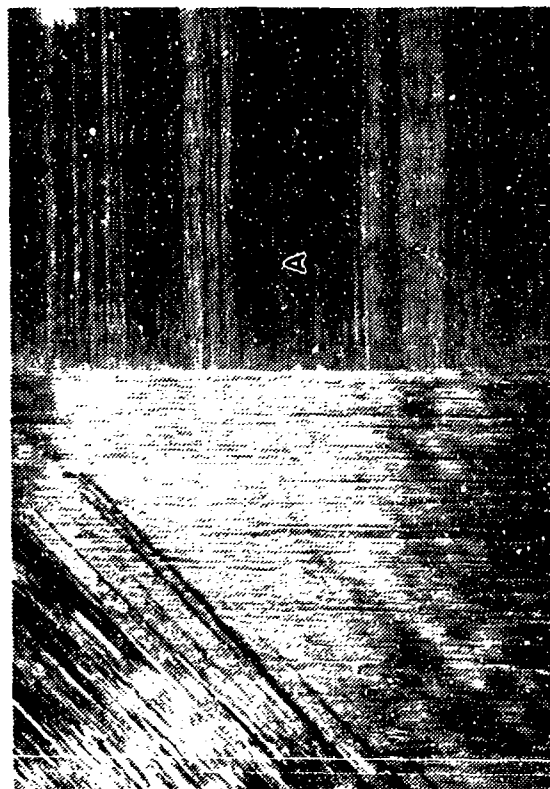
Figure 10-8. Optical and SEM Photographs of Fracture in Unidirectional Gr/Ep Bonded to Quasi-isotropic Gr/Ep Using FM 300 Adhesive, Large Lap/Strap Ratio and Tested Under Mode I Tension and Mode II Interlaminar Shear
(a) Macro photograph of Fracture
(b), (c) Low Magnification (4X) Photographs Showing Cohesive (C) and Adhesive (A) Failure Characteristics

CD = Crack-propagation direction

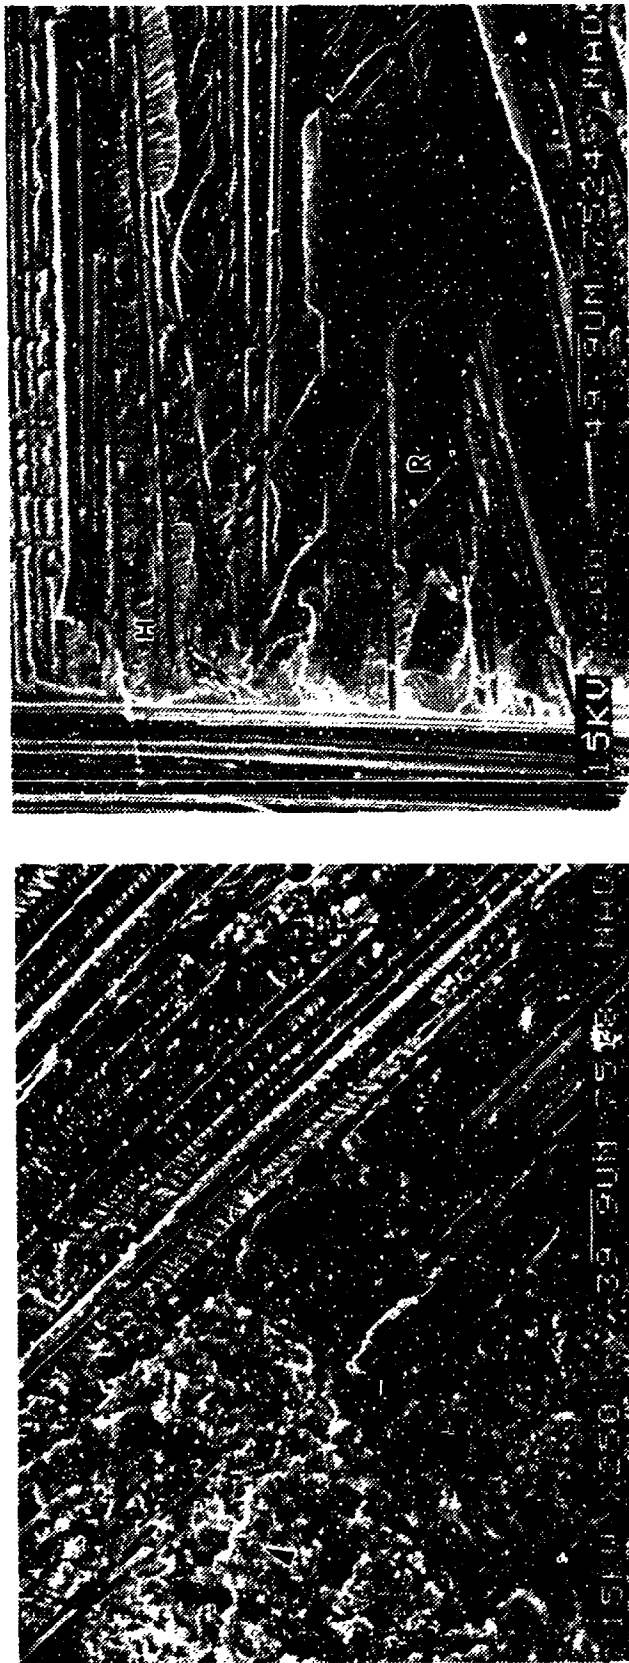
Figure 10-8. (Continued)
 (d) Cohesive Failure of Adhesive (Arrow) in Mixed Mode Failure Region
 (e) Hackles (H) and Rivers (R) in Adhesive Failure Region

CD = Crack-propagation direction

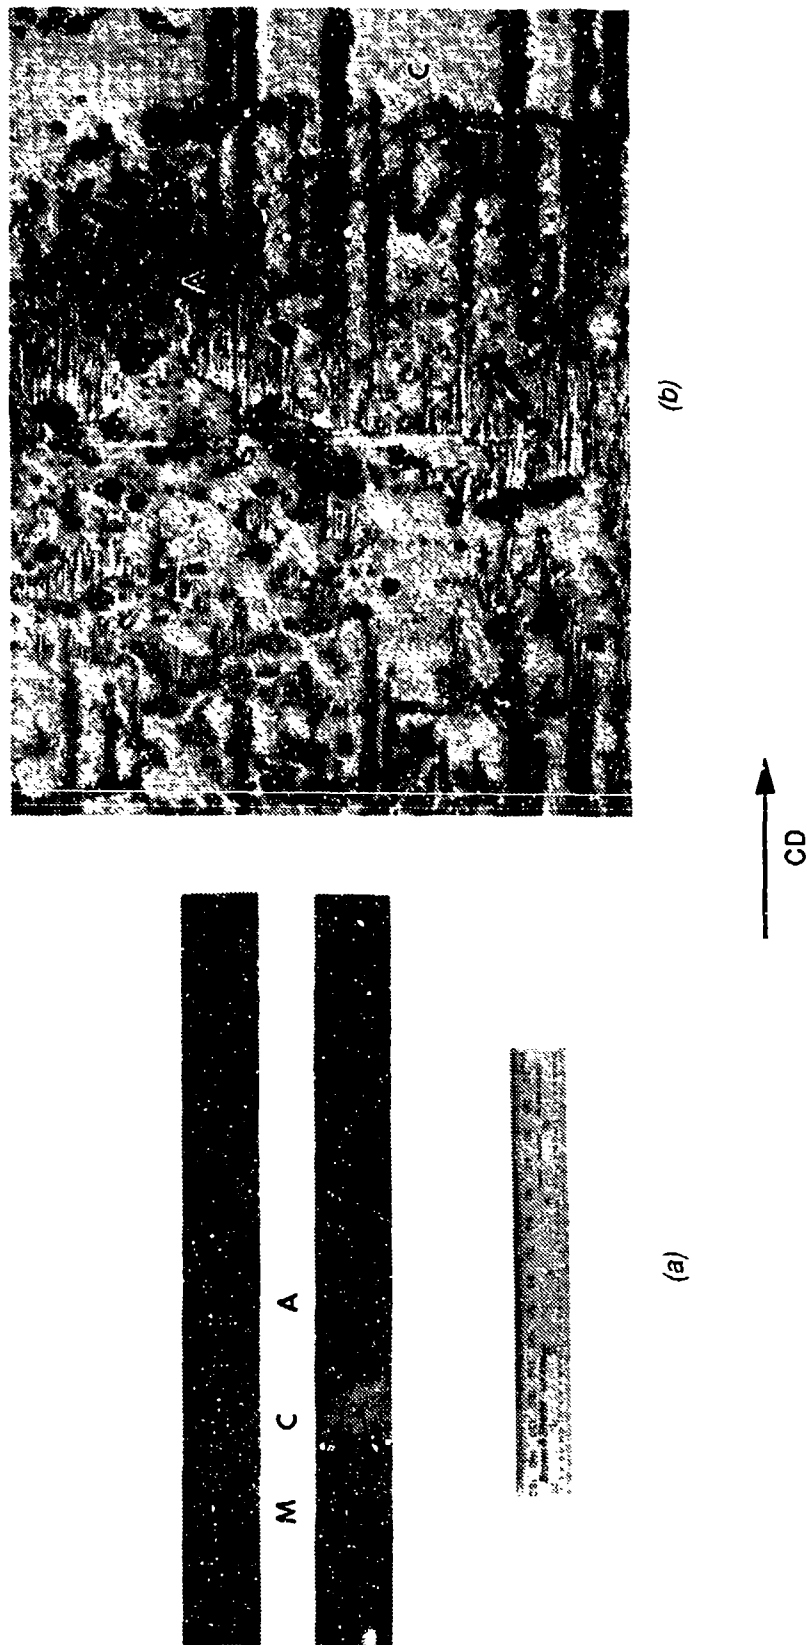
Figure 10-9. Optical and SEM Photographs of Failure in Unidirectional AS4/5250-3 Gr/BMI Bonded With EA 9673 Adhesive and Tested Under Interlaminar Mode I Tension
 (a) Macro photograph
 (b) Low Magnification (4X) Photograph Showing Details in Mixed Adhesive and Cohesive Failure Region

A = Adhesive failure
 C = Cohesive failure
 CD = Crack-propagation direction
 M = Mixed cohesive and adhesive failure

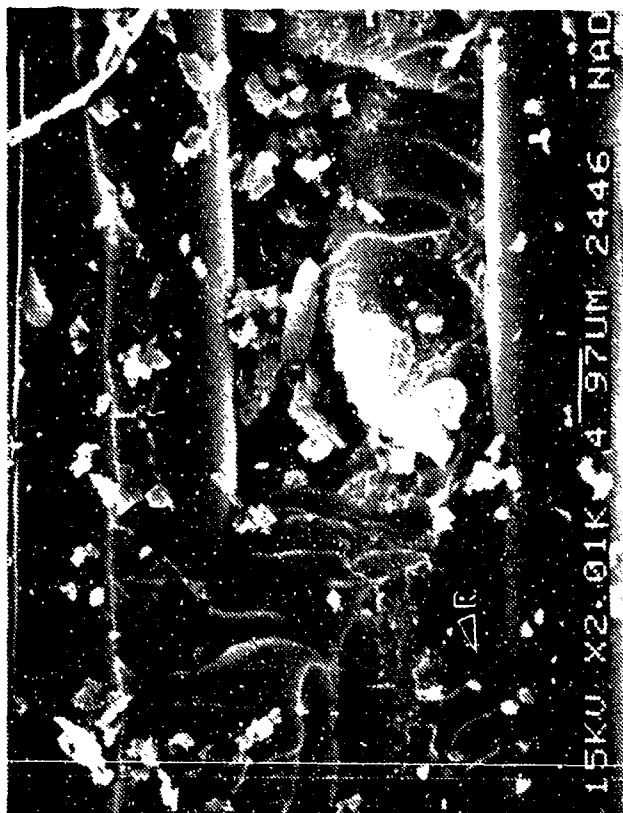
Figure 10-9. (Continued)
 (c) Low Magnification (4X) Photograph Showing Details in Cohesive Failure Region
 (d) River Patterns (R) in Adhesive Failure Region

C = Cohesive failure
 CD = Crack-propagation direction

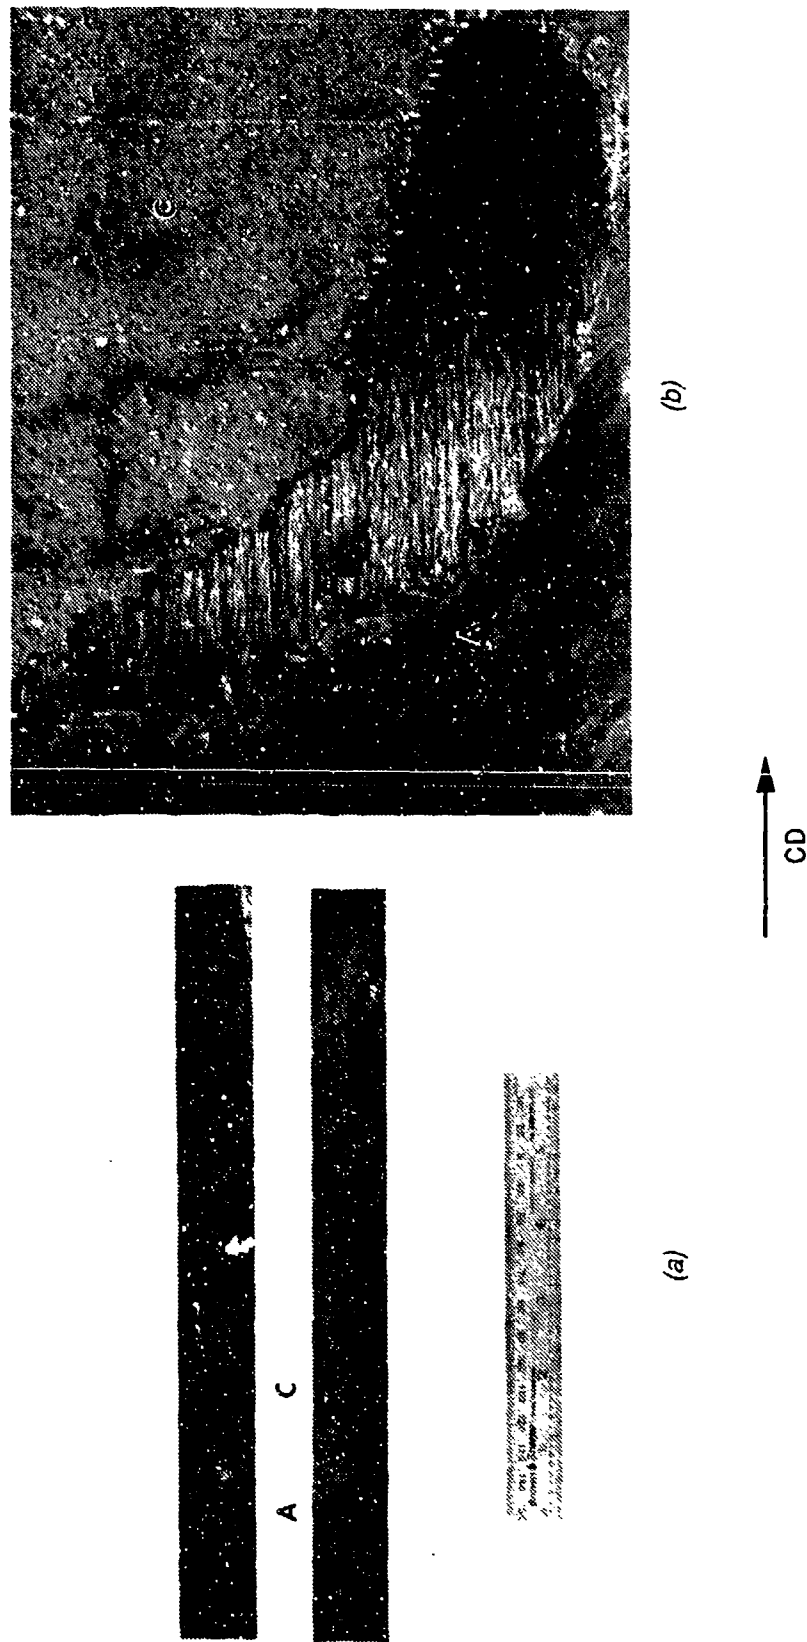
Figure 10-10. Optical and SEM Photographs of Failure in Unidirectional Gr/BMI Bonded to Quasi-Isotropic Gr/BMI With EA 9673 Adhesive and Tested Under Mode I Tension
 (a) Macro photograph
 (b) Low Magnification Photograph (4X) Showing Transition From Adhesive to Cohesive Failure

A = Adhesive failure
 C = Cohesive failure
 CD = Crack-propagation direction

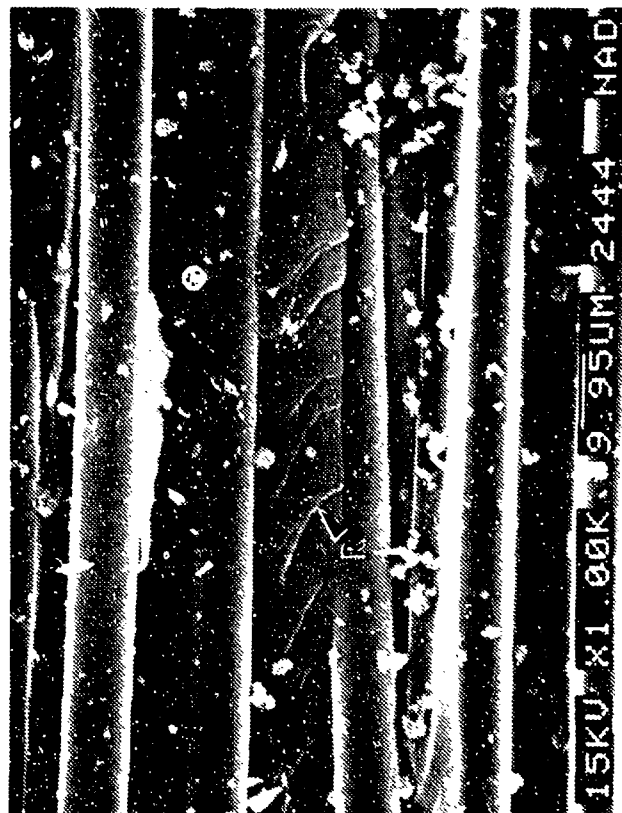
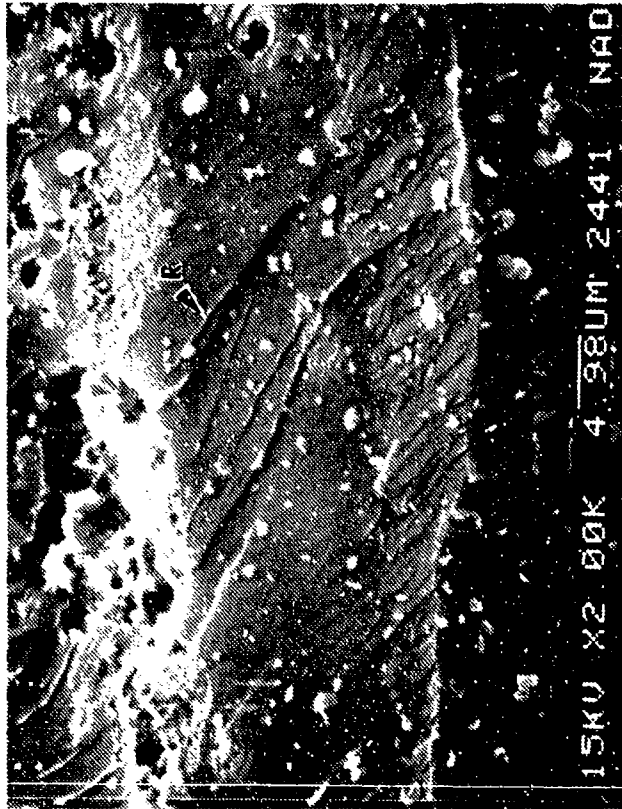
Figure 10-10. (Continued)
 (c) Adhesive Failure Area
 (d) Cohesive Failure Area

CD = Crack-propagation direction
 R = River patterns

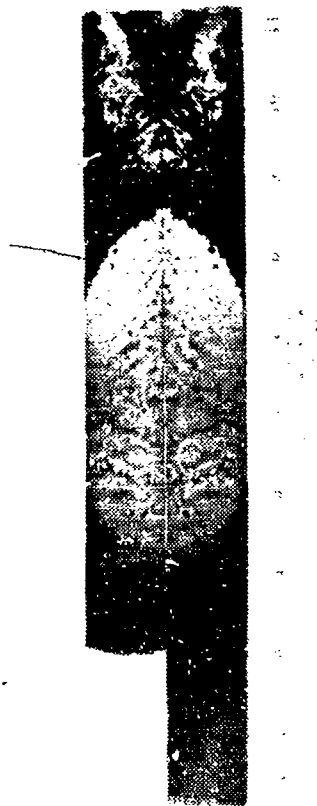
Figure 10-12. Optical and SEM Photographs of Fracture in Unidirectional Gr/BMI Bonded to Quasi-Isotropic Gr/BMI Using EA 9673 Adhesive, Large Lap/Strap Ratio, Tested Under Mode I Tension and Mode II Interlaminar Shear

(a) Macro photograph of Fracture

(b), (c) Low Magnification (4X) Photographs Showing Cohesive (C) and Adhesive (A) Failure Characteristics

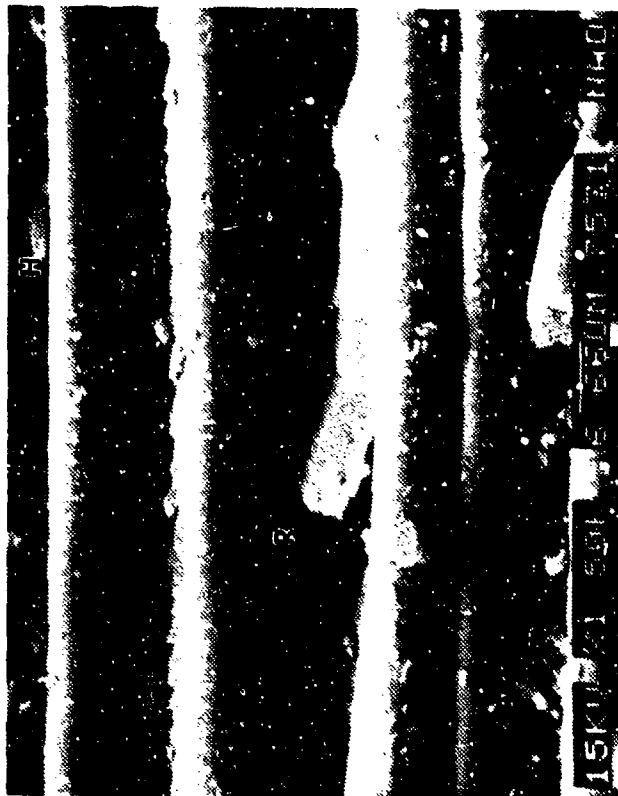
Figure 10-12. (Continued)
 (d) Cohesive Failure of Adhesive
 (e) Hackles (H) and Rivers (R) in Fractured Adherend
 CD = Crack-propagation direction
